DEPARTMENT OF ARCHAEOLOGY

GOVERNMENT OF INDIA

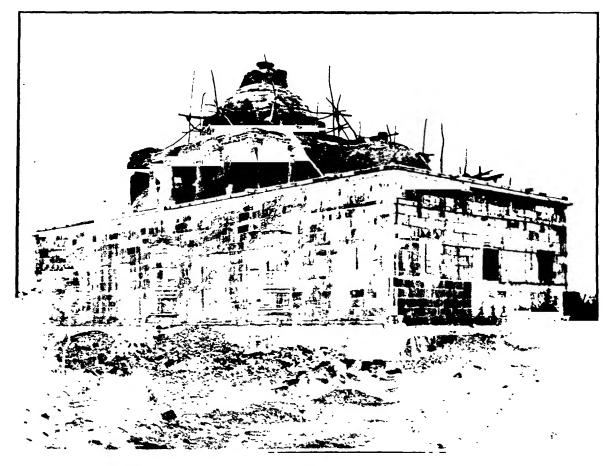
Lila Gumbaz, back wall, Champaner, before repairs

Lila Gumbaz, back wall. Champaner, after conservation

- During the year under review the largest amount of work was done at Champaner where Rs. 11,441 were spent on special Champaner. repairs and Rs. 1,204 in annual or current repairs. Champaner the back wall of the Kevda Masjid, the major portion of which had collapsed in September 1917, was rebuilt and strengthened. Kevda Masjid. The larger portion of the back wall of the Lila Gumbaz had collapsed in the meanwhile. The core of this wall was partly rebuilt and strengthened and outer facing of ashlar masonry Lila Gumbaz. was then reset and partly renewed (Pl. I). The concrete on the roof of the majority of monuments had cracked badly and a quantity of black soil had entered into the roof through these cracks. According to the report of Rao Bahadur S. K. Bhagvat, Executive Engineer, Kaira and Panch Mahals, which was endorsed by the Superintending Engineer, Northern Division, the entrance of black soil in the crevices and cracks caused leakage in the majority of

of the previous year's report). The roofs of the majority of monuments at Champaner were made watertight during the year under report. The special repairs of the monuments at Champaner were carried out very satisfactorily and the nature of the work accomplished reflects great credit on Rao Bahadur S. K. Bhagvat, Executive Engineer, Kaira and Panch Mahals, and Mr. V. M. Karandikar, Archæological Sub-overseer, Champaner, under whose immediate supervision the works were carried out. A part of the grant was utilized during the current year in clearing the jungle on the fort of Pavagadh hill to which no attention had been paid for number of years.

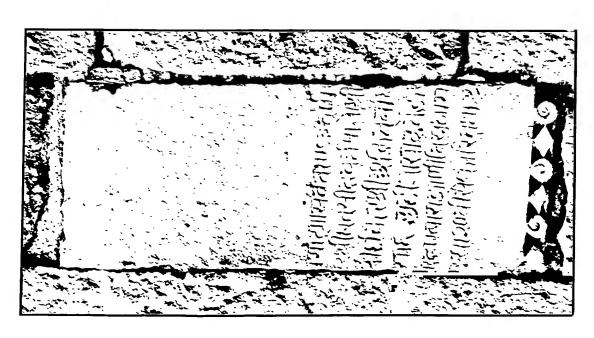
Chausat Khamba masjid, central mihrab Kaman.
